# 3 SITE ANALYSIS

### 3.1 LITTLE NOBBY

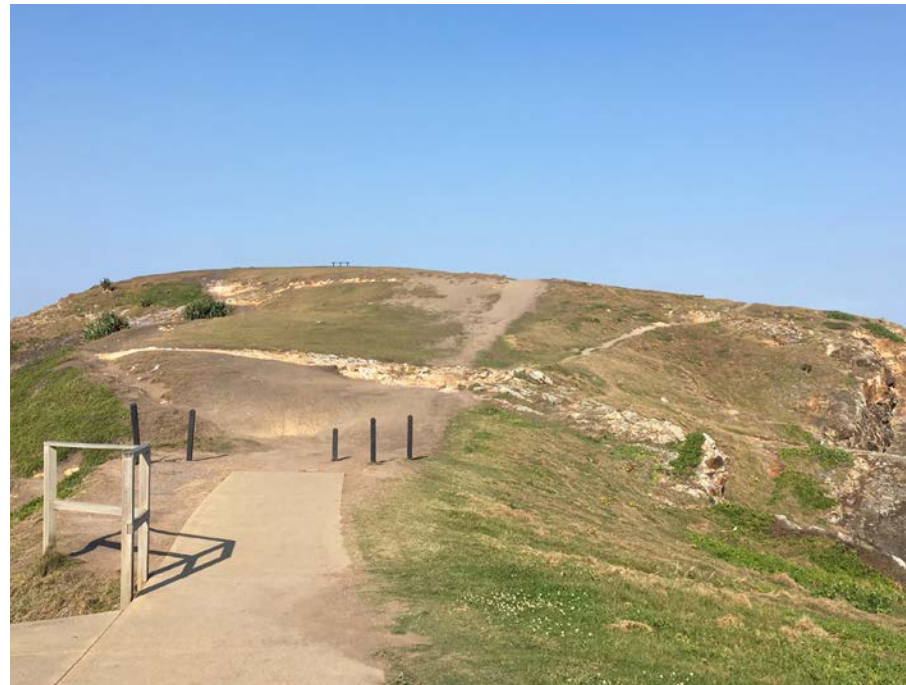
Tracking and erosion on Little Nobby

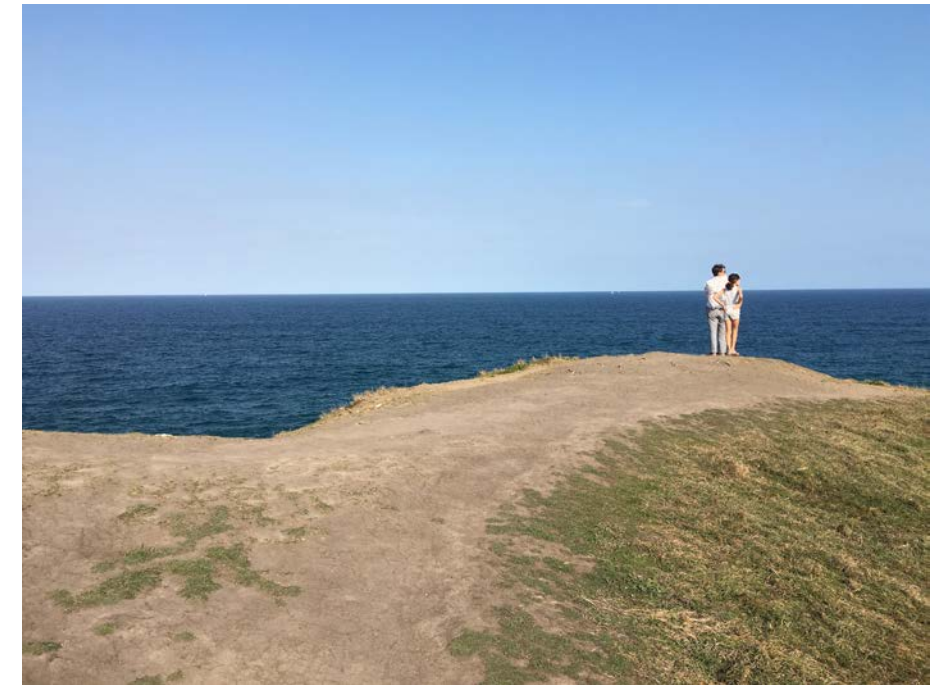
Tracking and erosion on Little Nobby

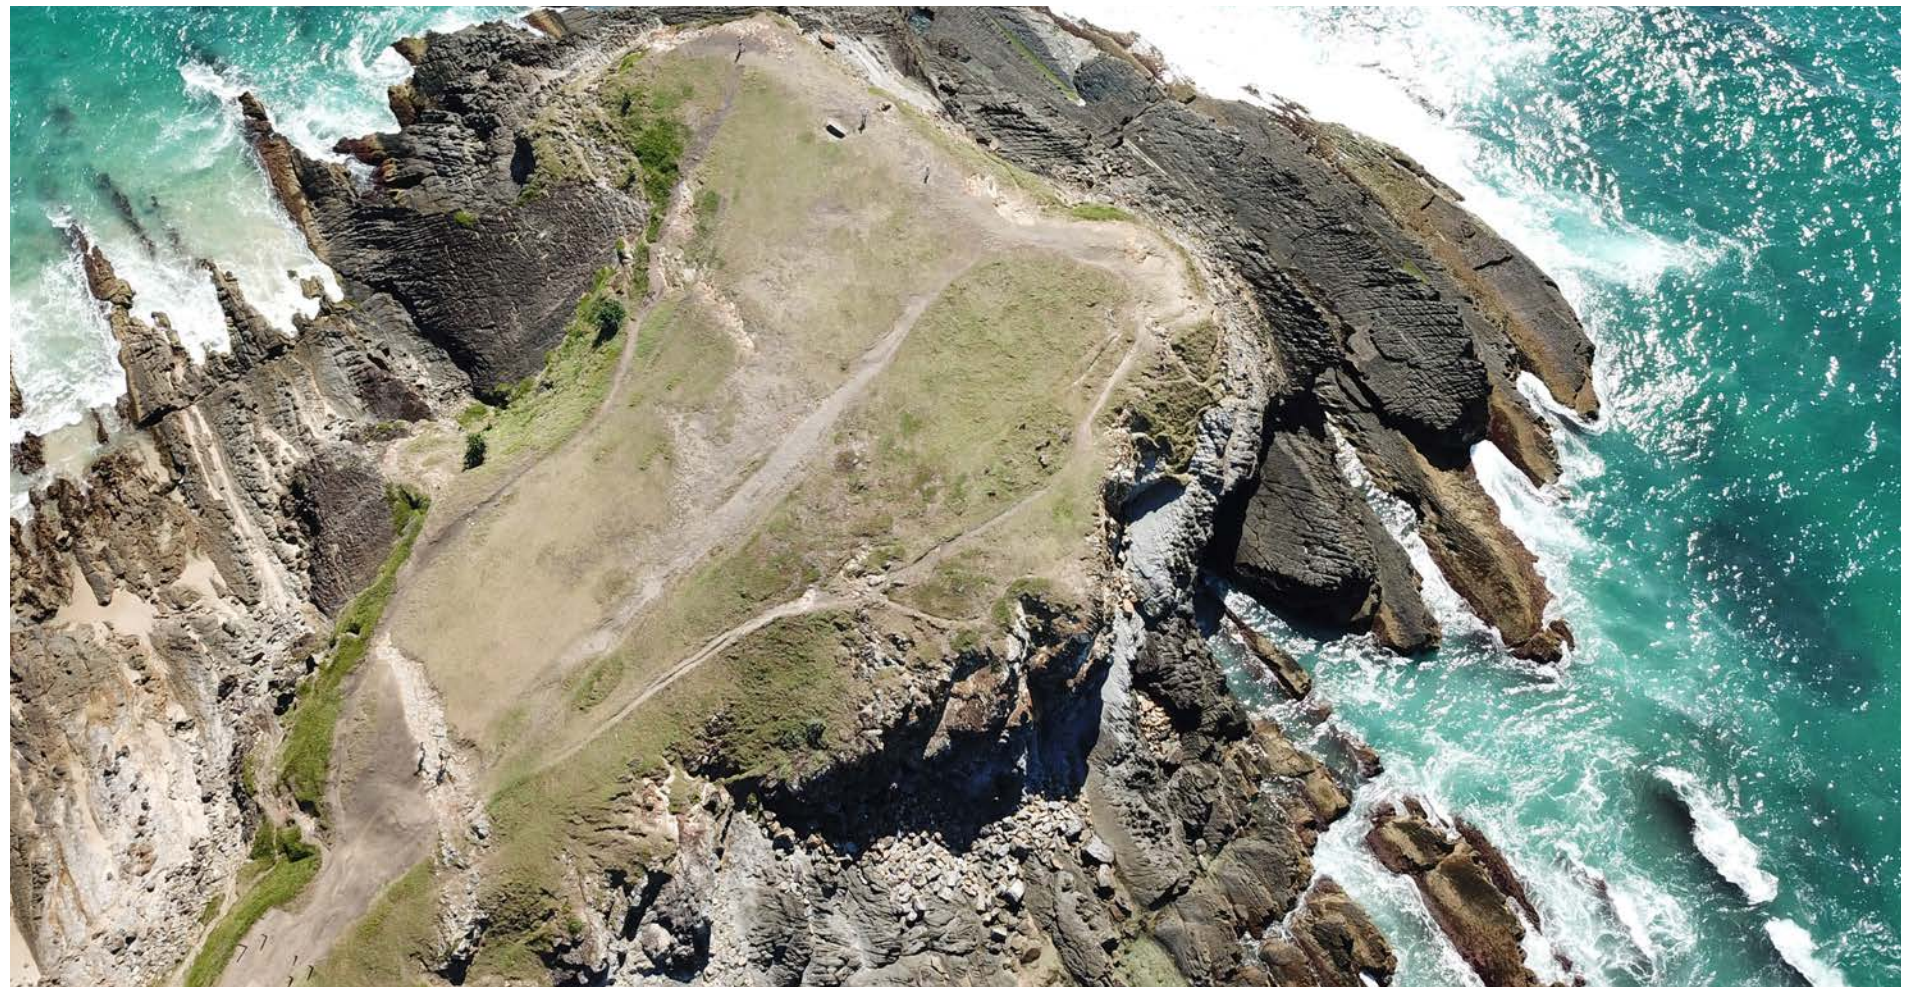
Existing tracking on Little Nobby

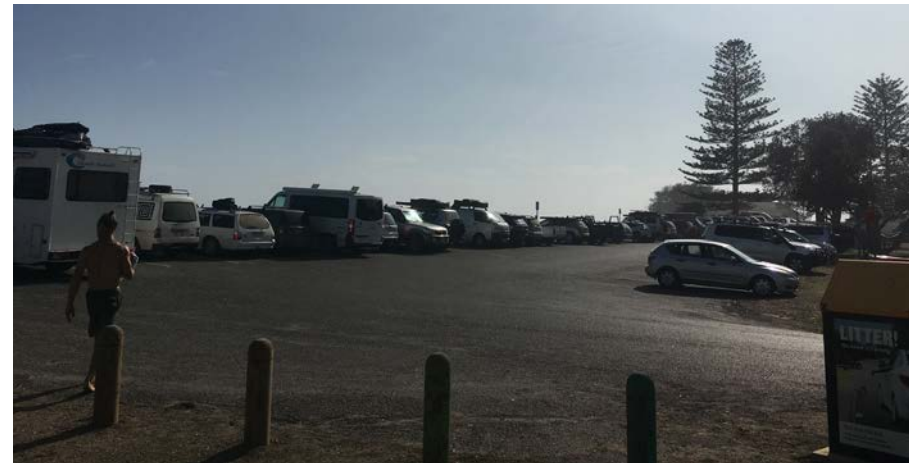
Current foreshore parking arrangement- and compromised public space

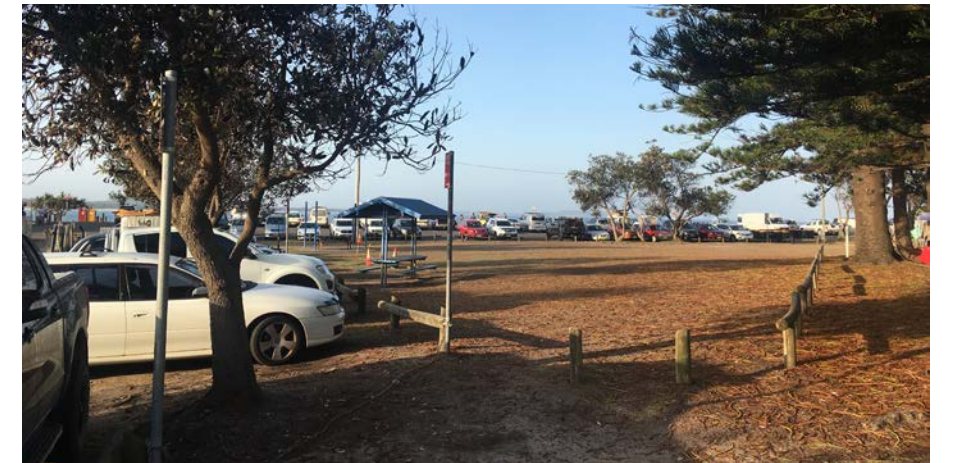
Public space compromised by land use and historic site planning

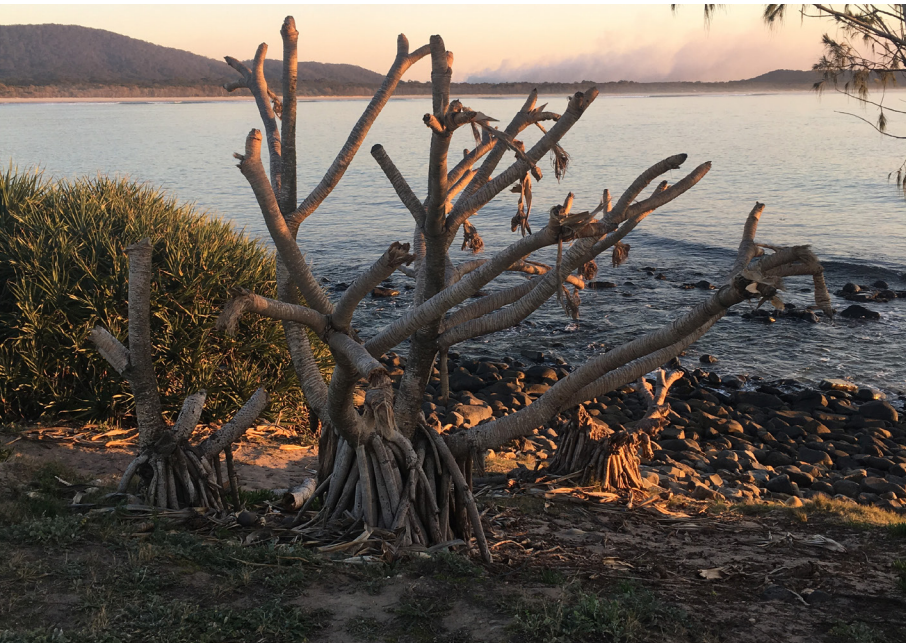
A number of Pandanus on the foreshore are in decline

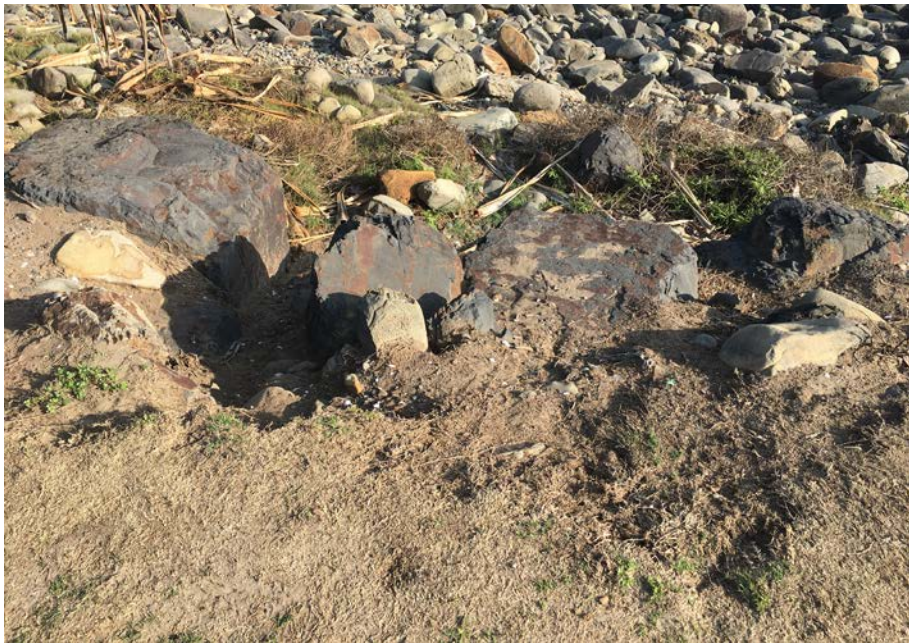
Tracking and erosion along edge of sea wall

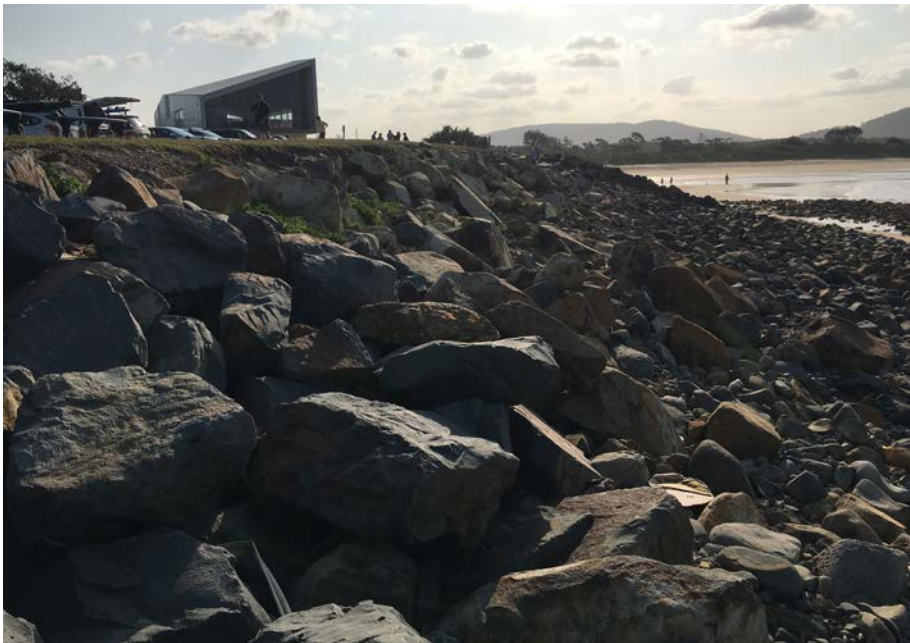
Existing erosion protection measures

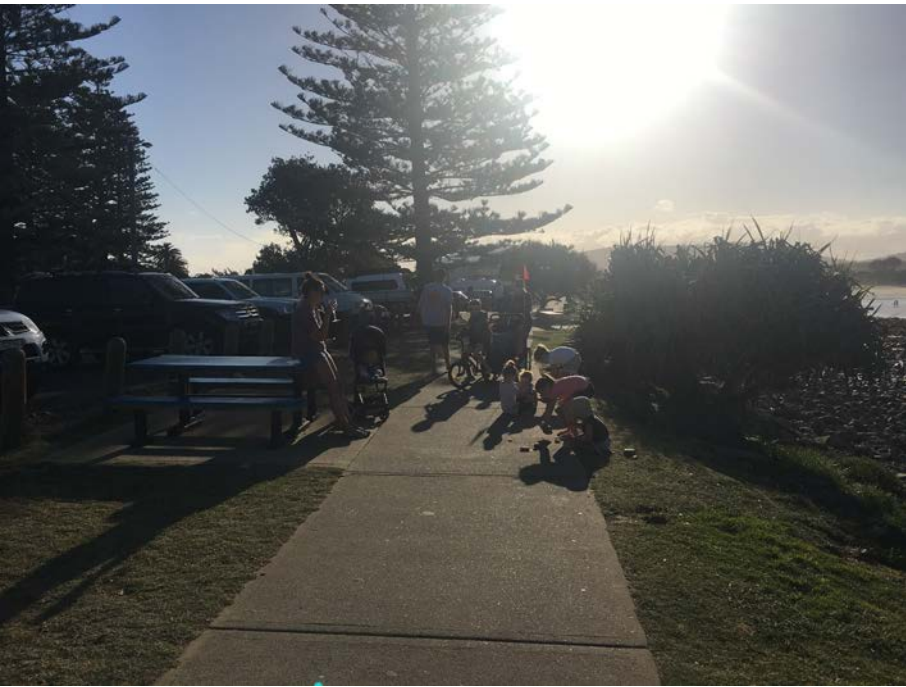
Potential highlights along the foreshore path are currently lacking in amenity and functionality.

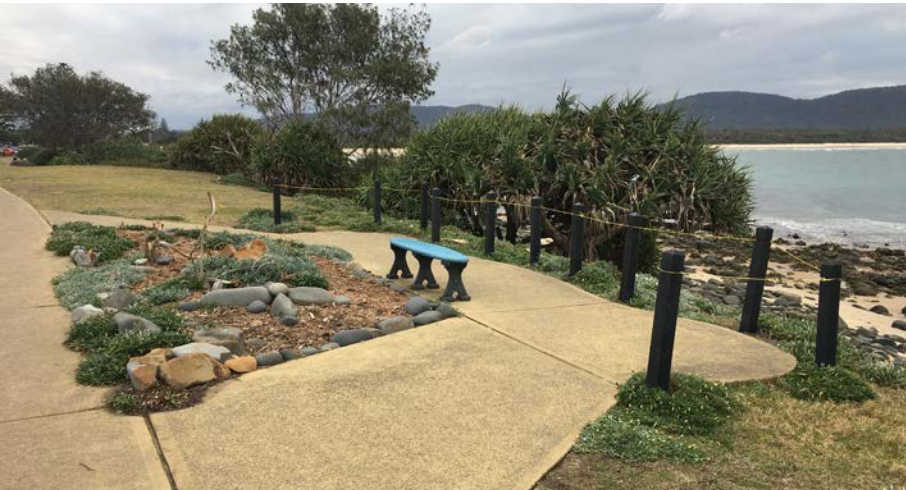
Critical junctures of the foreshore such as the entry / exit of the footbridge also become clogged at busy times.

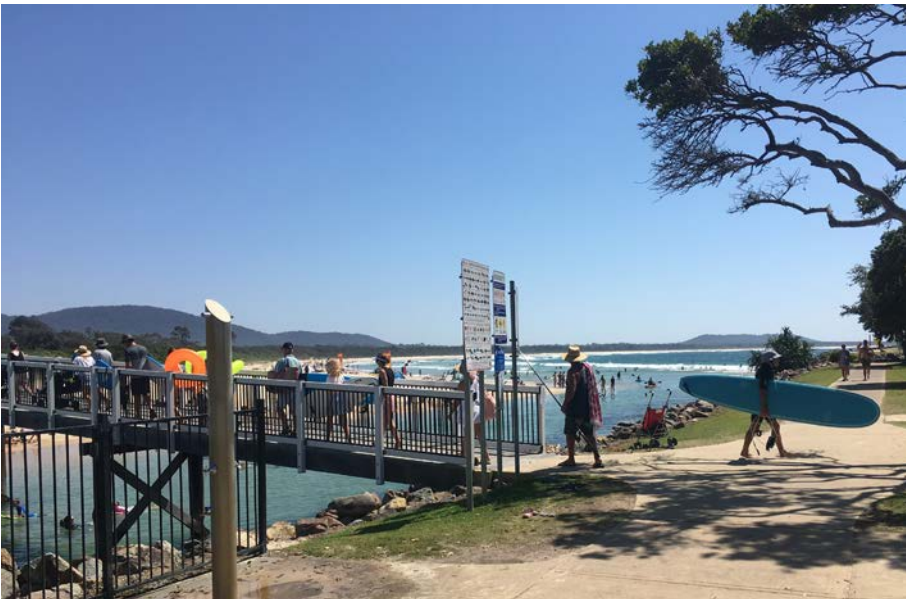
Safety- lack of proper footpaths at critical junctures of the foreshore, eg where Reserve Road enters the foreshore car parking areas lead to safety concerns for pedestrians. At present pedestrians are largely required to walk along the road and through the car park to access both the beach and the creek. The location for this lack of adequate pedestrian paths also coincides with one of the most congested and confusing locations for traffic flow in the village- the entry to the foreshore zone, the entry to the Holiday Park (both east and west sectors), and a roundabout. Refer to Section 4 of this document for proposed management measures relating to pedestrian and vehicular safety in this key foreshore zone.

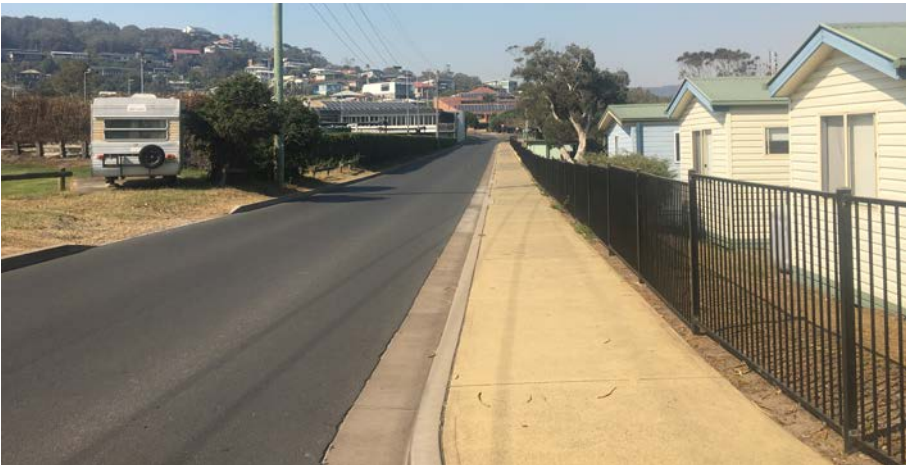
Reserve Road footpath- high levels of exposure and low levels of amenity

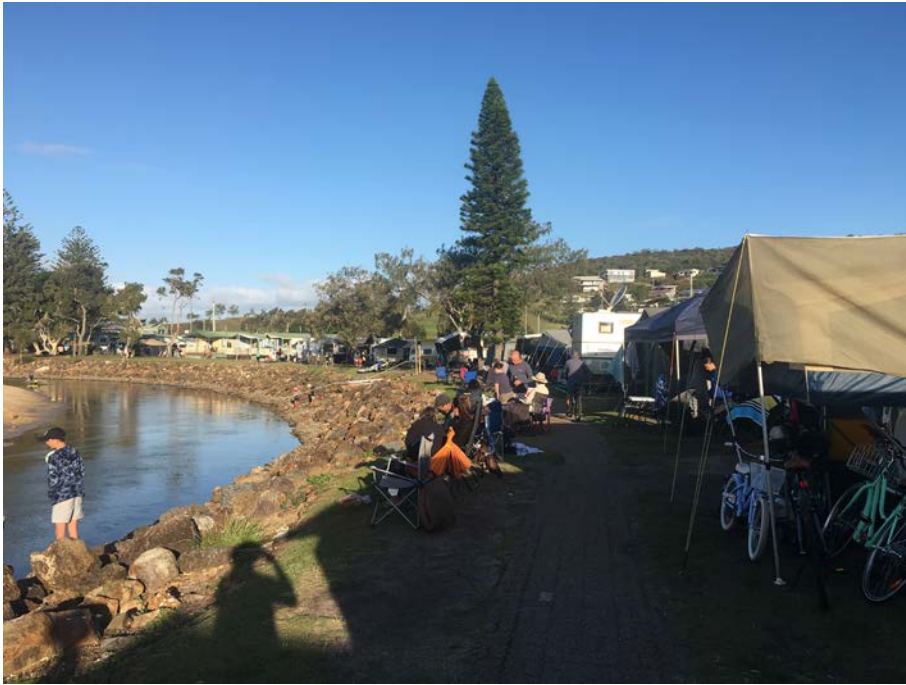
Similarly, residential 'privatisation' of the public foreshore strip renders tenure of space ambiguous.

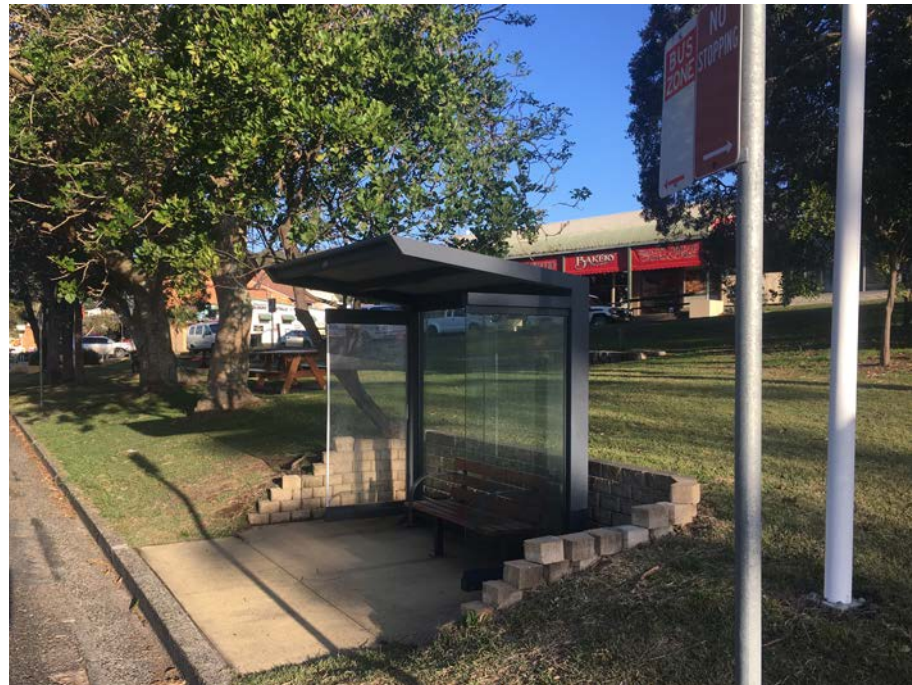
The main village centre bus stop is positioned on the Pacific Street frontage of the park. The existing bus stop is cut into the bank and is not accessible by any designated path.

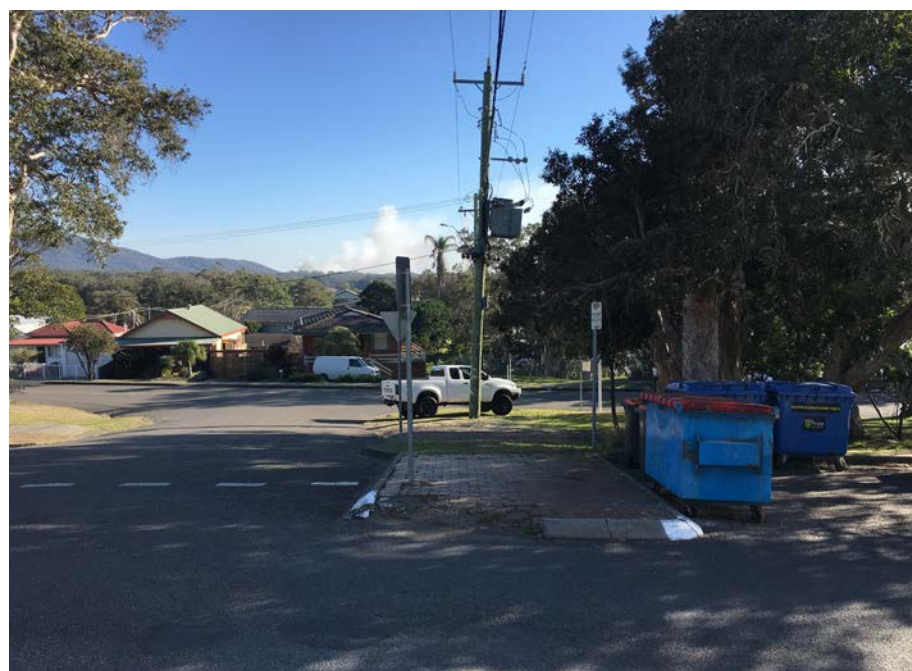
An existing element within Lloyd Park that currently negatively impacts park character and experience is the presence of several commercial rubbish bins in the south western corner of the park. Improved waste management from village centre businesses should be encouraged to reduce the bin numbers.

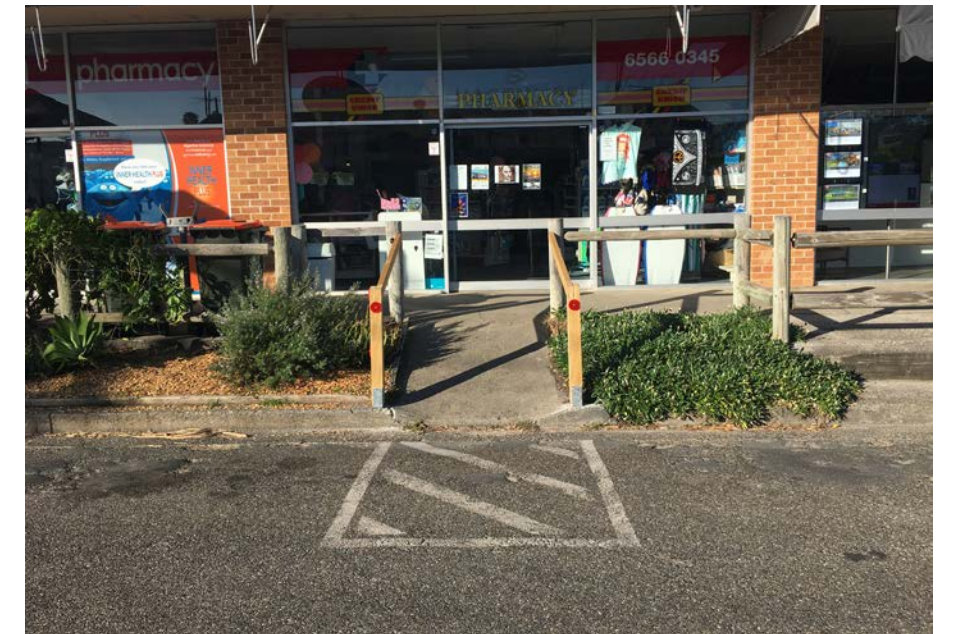
Access points creating safety concerns

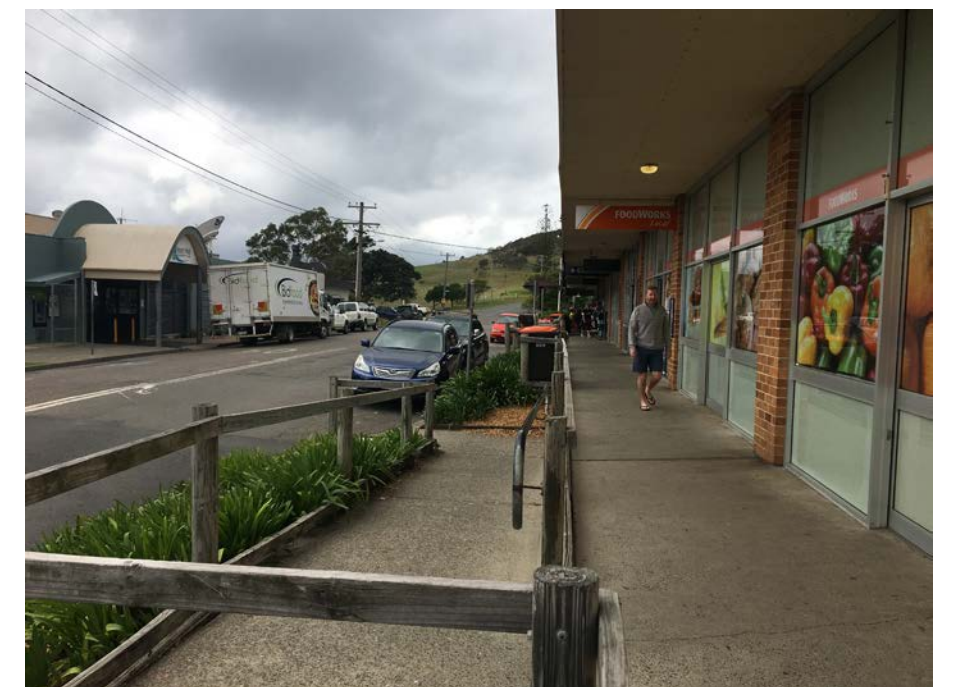
Existing accessible ramps on Rankine Street- poor quality access and amenity.

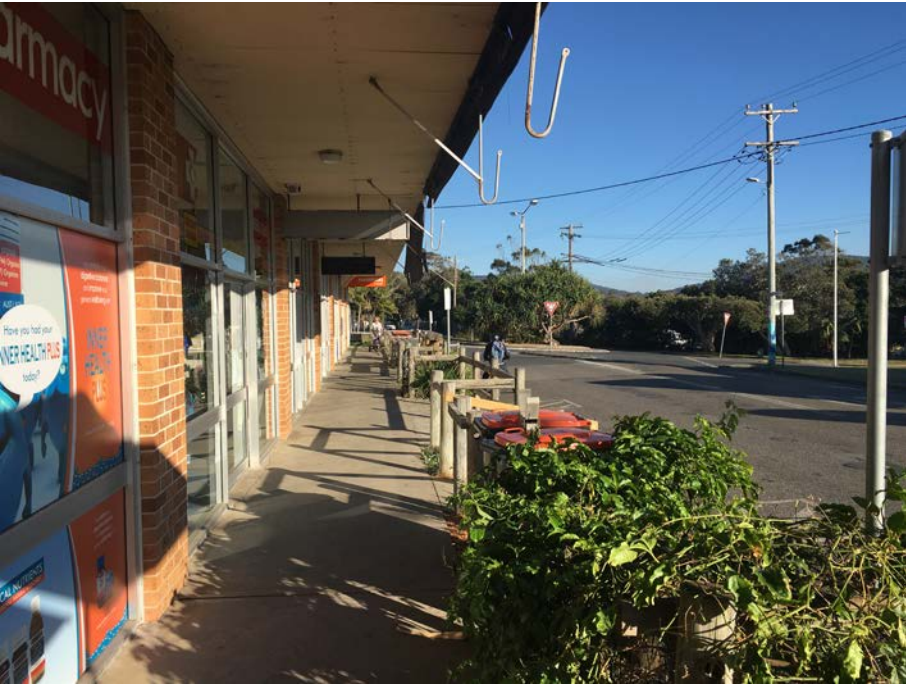
As with Main Street, the level transitions between street and shop front levels also result in congested public domain and street interfaces. Limited to no space for the planting of street trees for natural shade and amenity also negatively impacts street and village centre character.

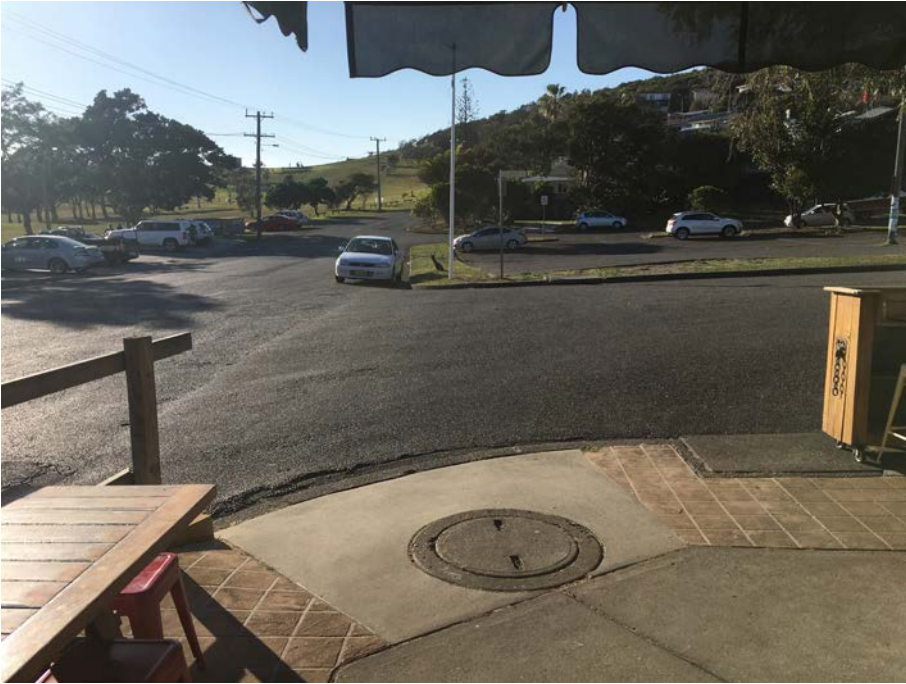
No kerb ramp and no footpath connection to the car park

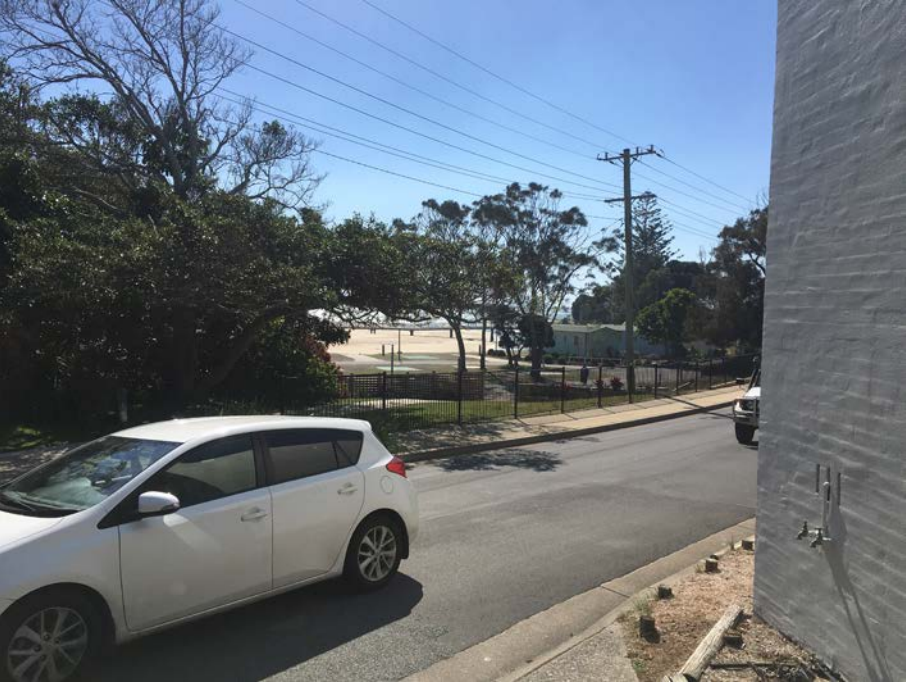
Blind corner and poor sight lines on the pedestrian crossing point of Reserve Road

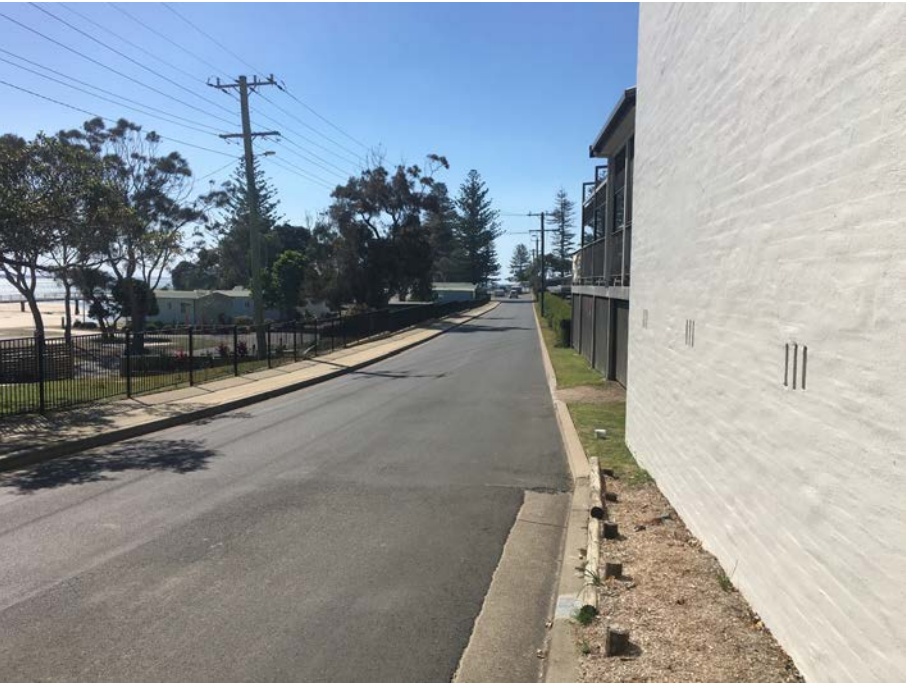
Limited space for pedestrian amenity
